Working safely on Heritage Parquetry flooring.

Ivan Kirton, We Love Parquet Wood Floors.

The case study is the Commonwealth Bank Building at No.5 Martin Place. The building itself was constructed in 1912.

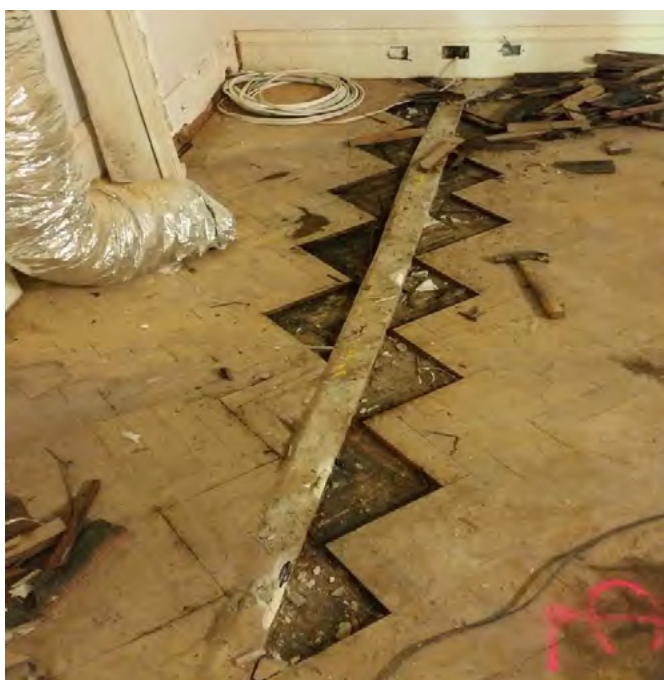
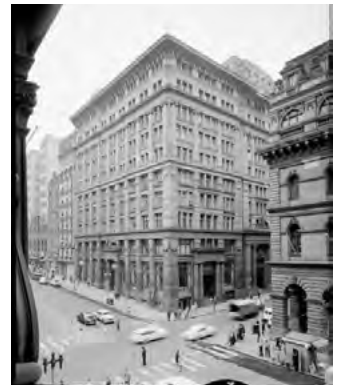
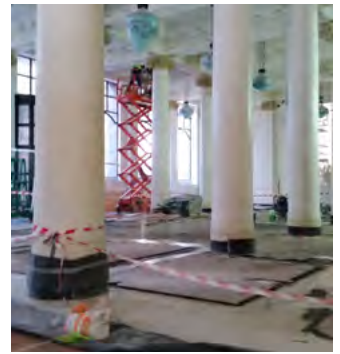
The image below is a typical type of repair, where the electrical conduit was cut into the original Jarrah Parquetry flooring to create new power outlets on the other side of the room. The flooring was then covered with carpet.

There was exposed parquetry adhesive throughout. Needless to say, the dust was everywhere.

Our job was to remove the cement and reinstall new parquetry flooring to the slab, stitching the flooring into the existing heritage floor.

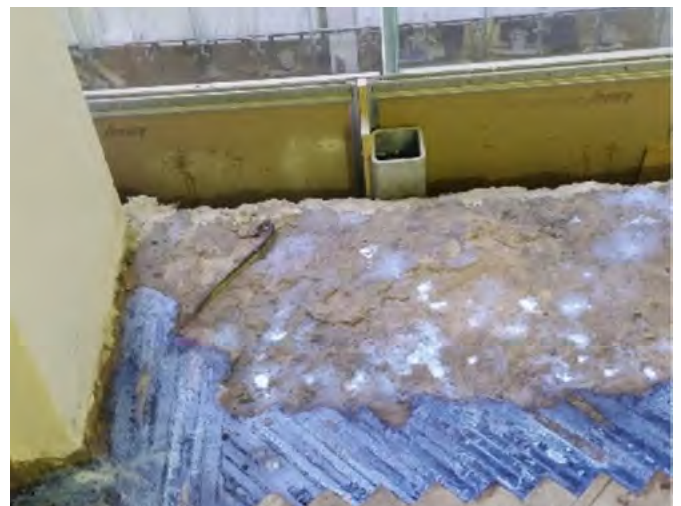
Wherever you may come into contact with old parquetry adhesive, you will need to vacuum it up using a HEPA filter or similar, and then seal the exposed adhesive. In this case we used a concrete primer.
