Introduction

This information sheet outlines reasonable owner expectations for an onsite sanded and finished timber floor. This includes solid T&G flooring, parquetry and other flooring types that have been sanded and finished onsite or recoated. Concerning this, there are performance aspects of the floor which generally relate to fixing integrity, board shape and movement, and then there are appearance aspects which focus more on the sanding and finishing.

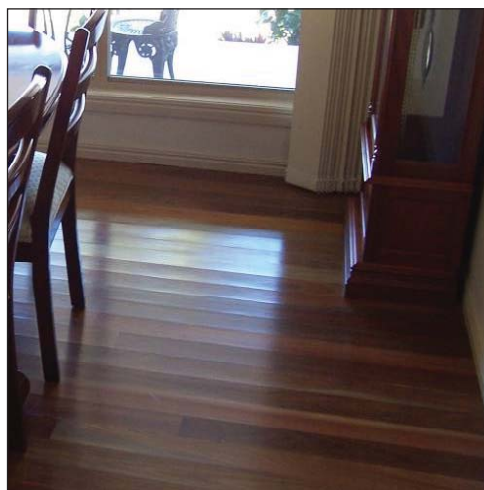
Observable peaking

Peaking – This has the appearance of cupping but is the result of expansion pressure in the floor. Again it is generally expected that a floor would be free of observable peaking.

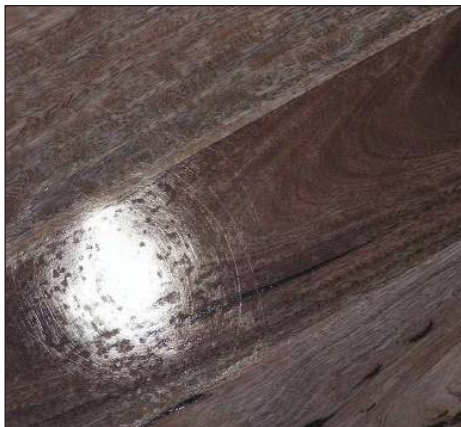
The photo to the left shows circular swirl marks that are visible under down light. The photo to the right shows the same section of floor in natural light without the down lights on and the swirl marks are not visible.

Swirl marks – Swirl marks are caused by rotary sanders and to some degree will be present in all floors. Down lights will highlight sanding imperfections due to light refraction through the coating and as such this is not controllable by the contractor. Fine swirl marks that are not obvious under natural light when assessing a floor should not be a concern.
