## 5.0 INTRODUCTION

## 5.1 ACCEPTABLE APPEARANCE

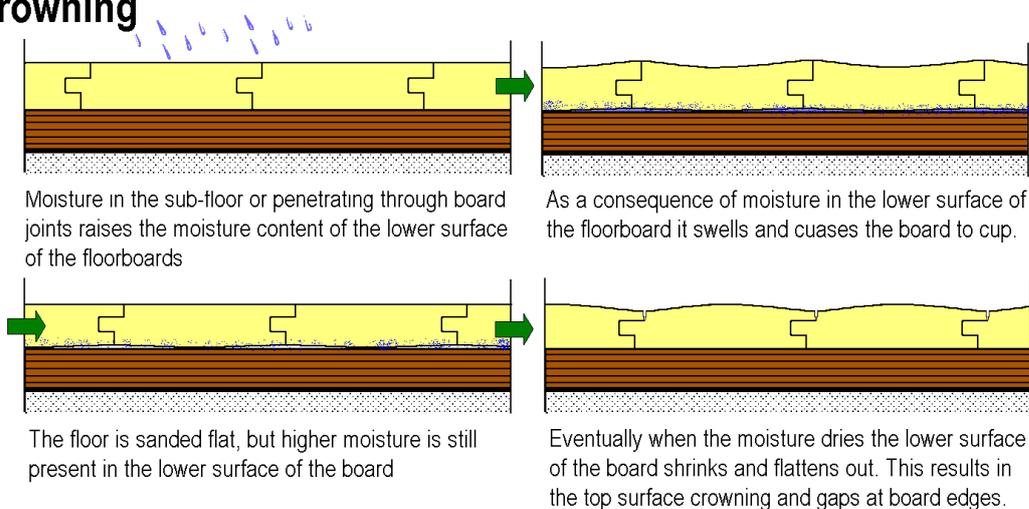
## Crowning

- Cupping - boards with their edges either higher or lower than the centre of the board. Heat in a specific location or a very dry environment above the floor may result in cupping. Moist sub-floor spaces can also cause boards to cup. Cupping is more likely to be observed in overlay flooring and standard thickness boards that are wider than 100 mm. To some degree a small amount of observable cupping may occur in some locations within a dwelling (e.g. sun exposed floor) where these types of flooring are used.

- Peaking – this has the appearance of cupping but is the result of expansion pressure in the floor.
- Tenting - two adjacent boards, where the adjoining edge has lifted above the level of the adjacent flooring. This is often associated with high moisture beneath the floor and can be from many causes.

*Note: Floors exposed to heat sources after occupancy (e.g. no curtains, fireplaces, vents from appliances, houses closed up for extended periods) may cause boards to cup. Cupping and shrinkage from such sources may be the owner's responsibility.)*
