Information for floor installers and owners of timber flooring

This information is provided for guidance when a timber floor has been inundated with mud and silt laden water typical of what has occurred in Queensland in January 2011. It does not apply to inundation from sea water and is limited to appearance of performance aspects of the exposed flooring product.

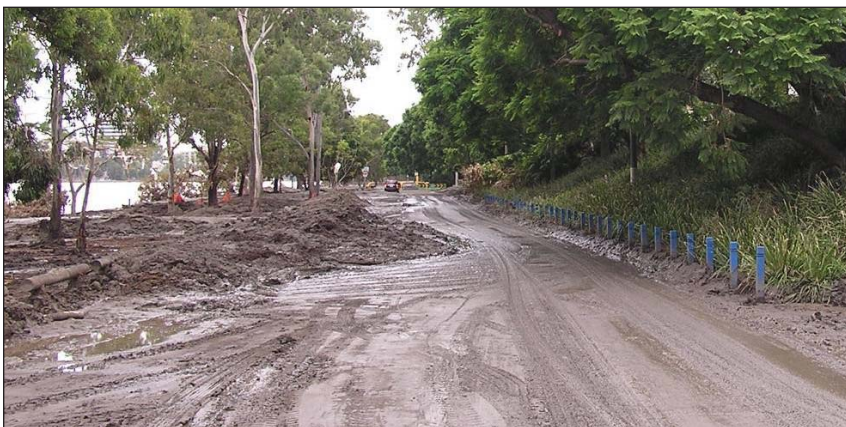
Mud and silt from the Brisbane River in 2011. The water rose to height exceeding the embankment to the right and inundated businesses and apartments.

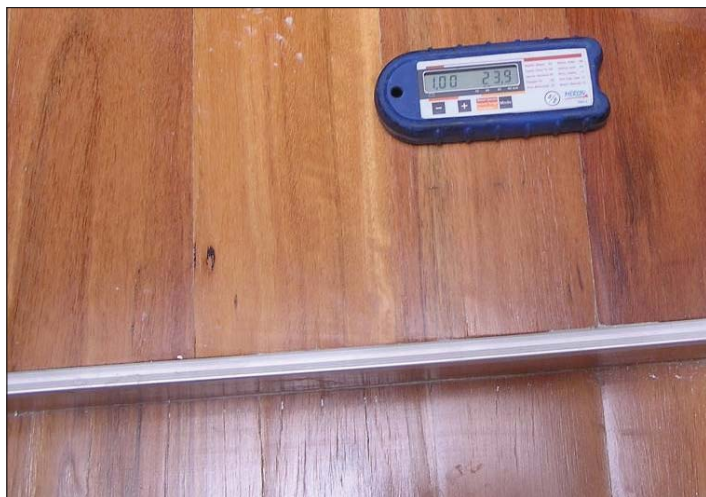
This engineered floor direct stuck to the slab was submerged in the Brisbane flood of 2011 with about half a meter of water over the floor. This photo is about 10 days after the flood. The plywood core layer remains high in moisture content but the floor although having a crowned appearance is still firmly fixed to the slab. The water had also resulted in some expansion in the floor and checking (or splits) in the surface. Greater moisture penetration was evident at board end joints and board ends abutting walls and doorways. A similar direct stuck floor that had been removed had minimal mud and silt beneath.

We would expect that in most instances these floors irrespective of whether they are laid on plywood, battens or direct to slab, that they will need to be replaced due to entry of mud and silt and difficulties in drying these floors. Although, in some situations direct adhesive fixed floors could be recoverable and in such instances steps to remove mud and silt from the surface and drying as outlined above may be employed.
